APPENDIX F: QUINULT RIVER TIME-LAPSED PHOTOGRAPHY

Cameras were installed on October 27, 2001 to take time-lapsed photography of the Quinault River during the 2001-2002 winter flood season at two sites along Graves Creek Road. The time-lapsed photography provides researchers and biologists at the Bureau of Reclamation, Olympic National Park, and the Quinault Indian Nation information to better understand the process linkages of flooding, bank erosion, and the transport and deposition of large woody debris. This will help provide resource decision makers with information to help implement fish habitat structures that both improve fisheries while also protecting important infrastructures such as roads and bridges.

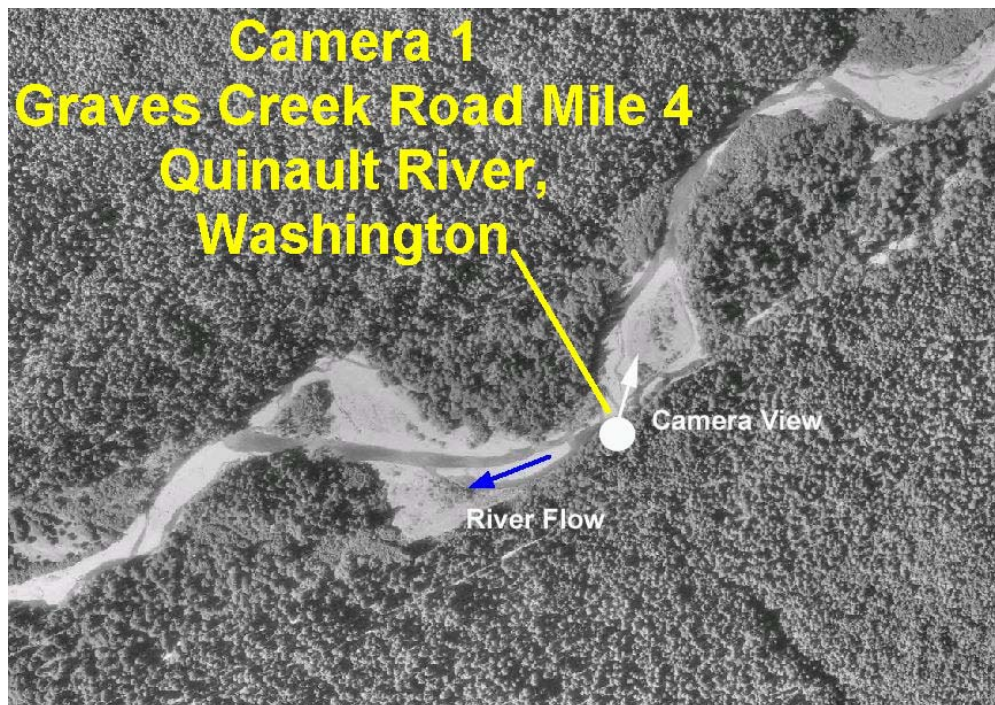
Figure 1. Planview location of camera 1.

Two camera locations were chosen along Graves Creek Road, which runs along the south (left looking downstream) side of the east fork of the Quinault River (upstream of the Forks). Site 1 represents an area where the left bank adjacent to the park road is made up of primarily bedrock and is therefore naturally protected (Figure 1 and 3). Site 2 represents an area where the river is eroding the left bank along the park road and rock protection has been used to protect the bank (Figure 2 and 4).

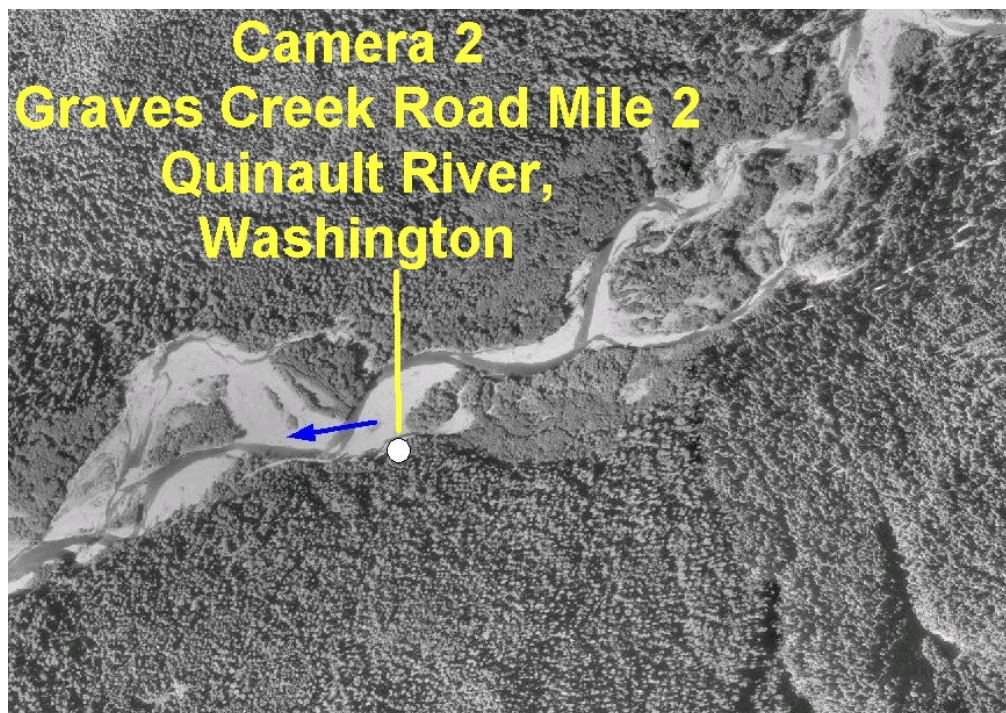
Figure 2. Planview location of Camera 2.

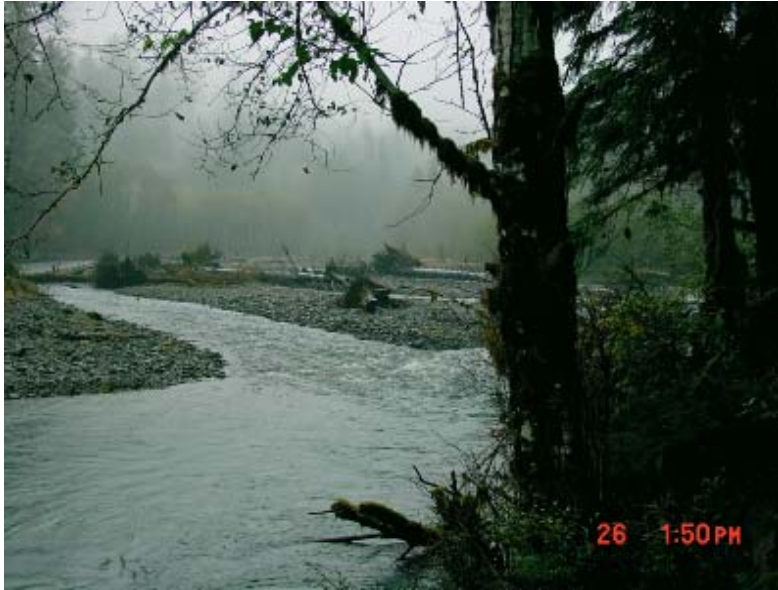
Figure 3. Site 1 River View - Looking upstream at Quinault River at upstream site with bedrock banks adjacent to park road. The goal of the camera is to observe natural interaction between woody debris transport and gravel bar formation.

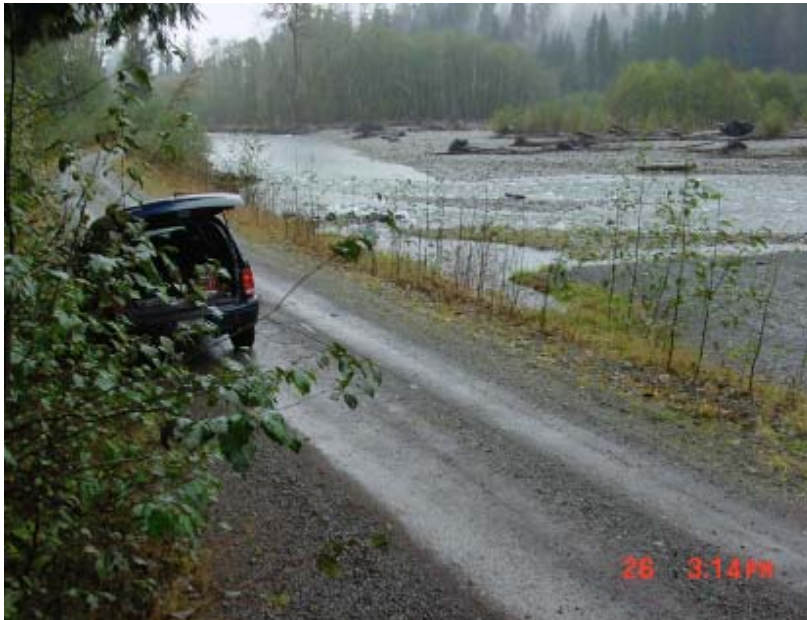
Figure 4. Site 2 River View - Looking downstream at Quinault River from camera 2 where barbs have been placed and additional bank protection is likely to be implemented, about 2 miles downstream from Site 1. The goal of the camera is to observe any additional impacts from high flow events and migration of the channel due to existing barb structures or additional bank protection if placed.

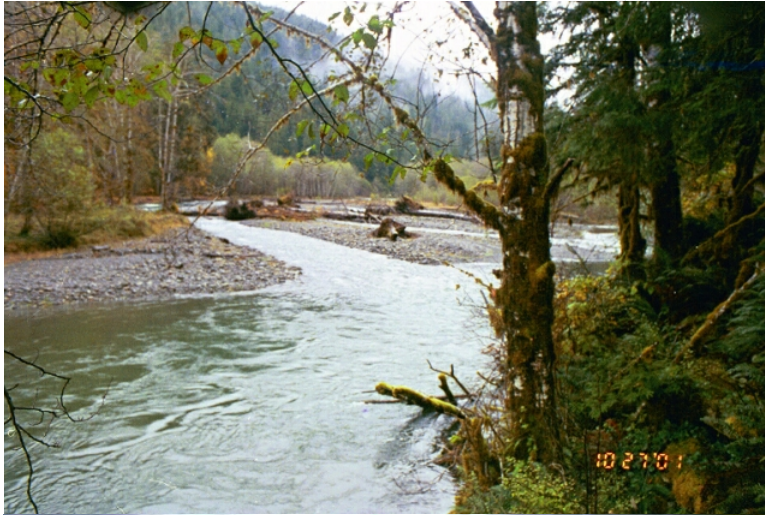
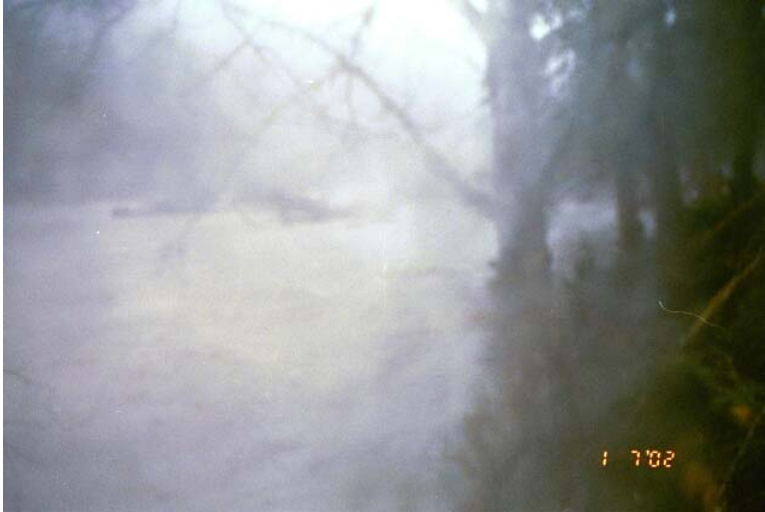
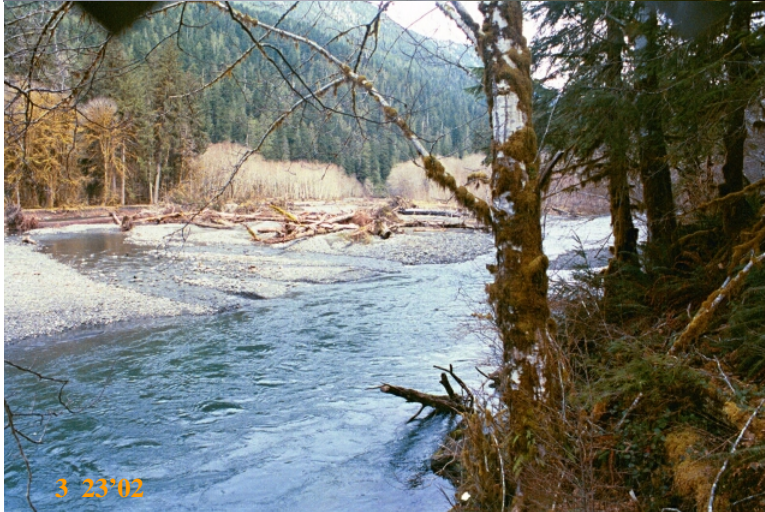
CAMERA 1 SUMMARY PHOTOGRAPHS (Date recorded shown on photograph)

Each site showed significant transport and reworking of gravel bars and large woody debris. The video is the best way to see the day to day dynamics, but the before and after photographs are shown below for each site, along with an in-between photograph time showing the highest flood recorded at the USGS gage on January 8, 2002 (highest stage observed at each camera site on January 7, 2002).
